**ROUND VALLEY NORTH DAM**

**ROUND VALLEY DYKE**

**PHASE I INSPECTION REPORT**

**NATIONAL DAM SAFETY PROGRAM**

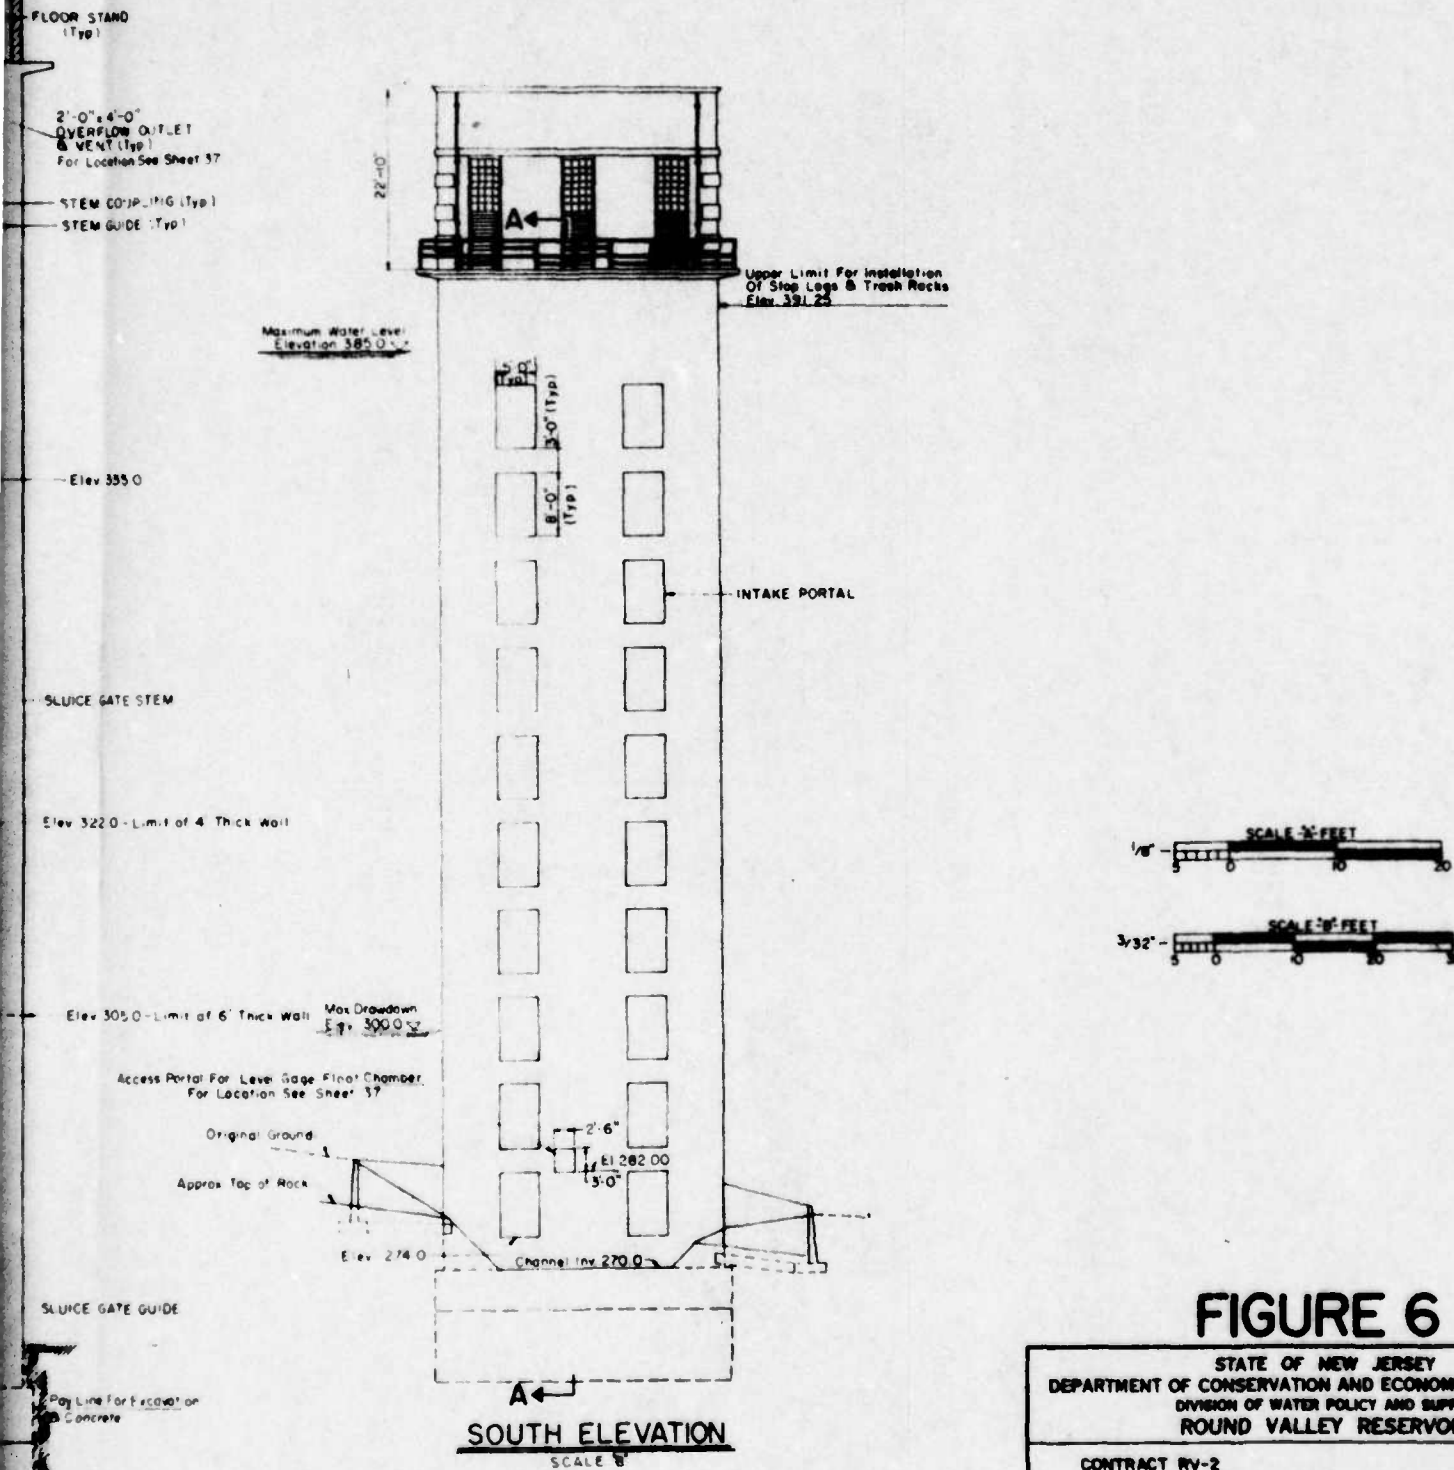
**FIGURE 6**

d. Outlet Tower and Appurtenances (See Figure 6) - The condition of the Outlet Tower and bridge appeared to be excellent. The gates could not be operated during the inspection, but Mr. Chase, Supervising Engineer at the Bureau of Water Facilities Operations, in Clinton, New Jersey, stated that no problems have been encountered during gate operation. The assemblies and motors showed no external signs of wear or deterioration. A mobile gasoline operator is available for use, in case of an electrical failure. Stoplogs are available for use. The valve vault located about 1,000 feet downstream of the embankment also appeared in good condition. The inspection team walked the 72 inch diameter discharge pipes to the base of the Outlet Tower. The 72 inch lines are normally pressurized only during testing at the release works. At the base of the Outlet Tower, an insignificant amount of seepage was noted through the tower wall, as well as minor honeycombing of the concrete. The pipes are coated with coal tar epoxy enamel. At the joints, some rust had broken through the coating, but it is not serious.

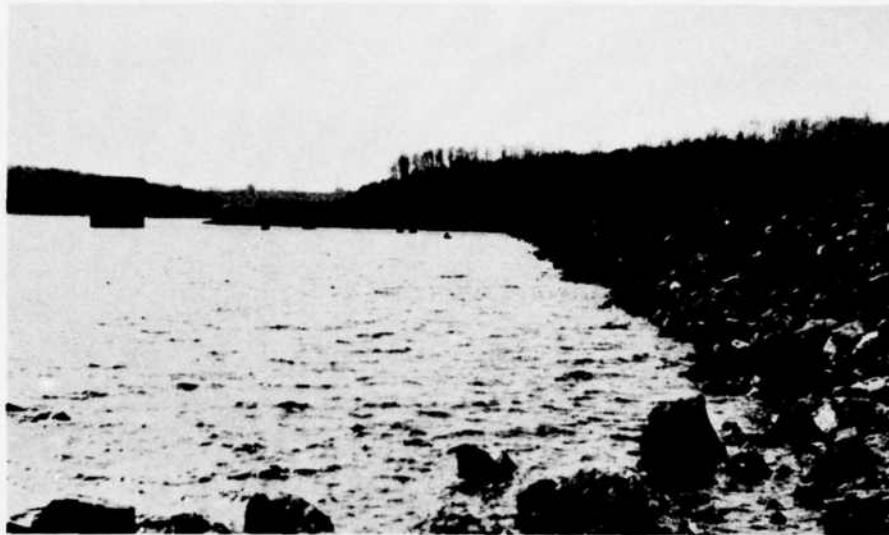
OUTLET TOWER AND UPSTREAM FACE OF NORTH DAM

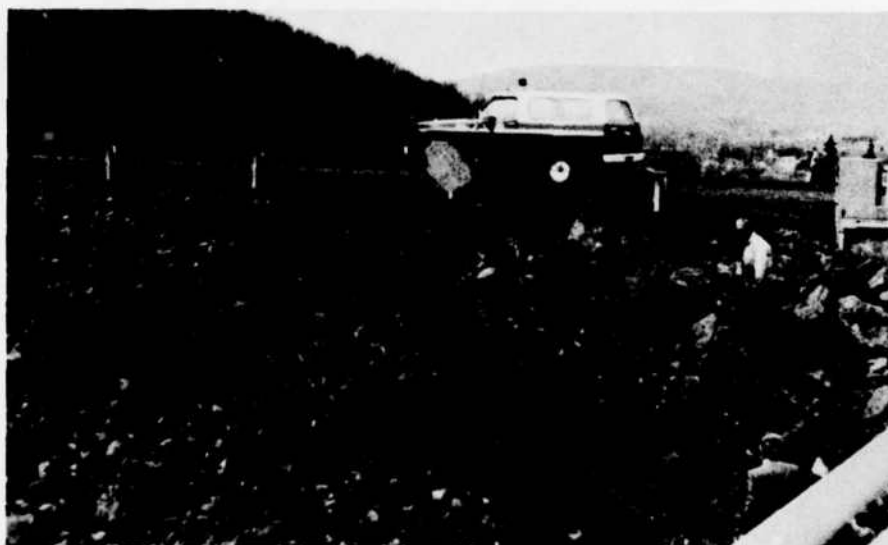
b. North Dam - The riprap on the upstream face of the dam is a poorly graded mix of large angular rocks (2 to 4 feet in diameter) and small rocks (6 inches or less in diameter). There is little uniformity in the distribution and placement of the rocks. The upper portion of the embankment appears to differ from the design drawings. The drawings indicate a 3:1 slope for the upstream face with no benches. The visible portion of the upstream face appeared to have a steeper slope (about 2:1) and a 10 to 15-foot bench just below the water surface. Some driftwood was noted within 2 to 3 feet of the top of the dam. On the east side of the embankment is an area of about 25 square feet that is free of riprap.

The riprap on the upstream slopes is poorly graded and inadequate to provide the necessary protection against wave erosion. The rock appears to have been susceptible to stress release or frost-wedging against fracture planes. According to Mr. Chase, considerable deterioration of the rock has occurred since its placement at the time of construction. Subsequent wave action has left portions of the embankment unprotected. The vertical cracks along the crest of the North Dam could be simply a sign of temperature change or could indicate a more serious condition relating to lateral movement.

POOR GRADATION OF RIP RAP ON NORTH DAM  
EMBANKMENT

c. Within one year from the date of approval of this report, the upstream slope protection should be repaired to provide a suitable well graded riprap layer.
